PIC16F627A/628A/648A

PIC16F627A/628A/648A Rev. A Silicon/Data Sheet Errata

The PIC16F627A/628A/648A parts you have received conform functionally to the Device Data Sheet (DS40044F), except for the anomalies described below.

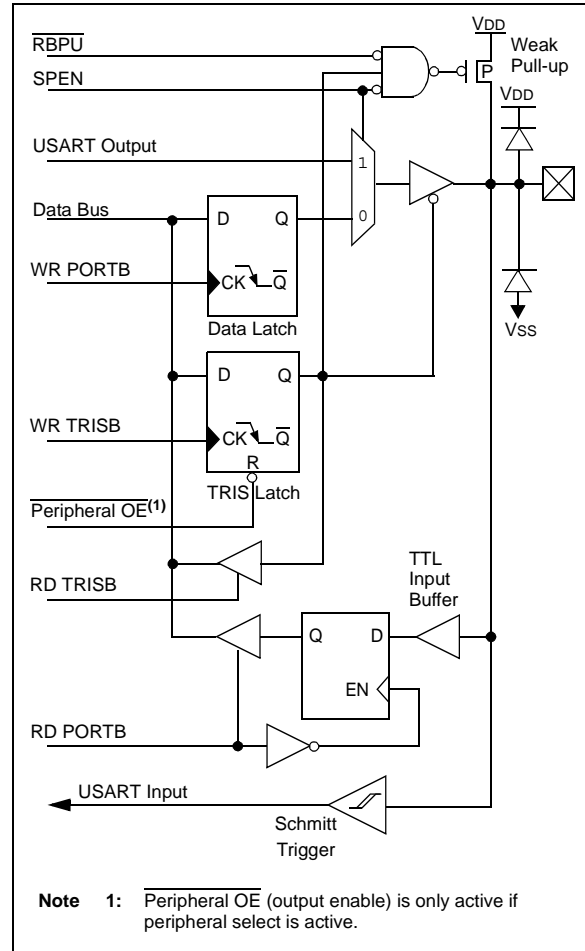
FIGURE 1: BLOCK DIAGRAM OF RBI, RB2

1. USART control of the RB1/RX/DT and RB2/TX/CK differs from the data sheet. Figure 5-9 and Figure 5-10 indicate that the USART circuit overrides the output drivers via the Peripheral OE signal. In fact, the Peripheral OE signal forces the TRISB<2:1> to an output (Reset) state (see Figure 1). Subsequently, the TRISB<2:1> must be set or configured to receive data.

In Asynchronous mode, when transmit is enabled (TXEN = 1 and SPEN = 1), the TRISB<2> latch is cleared to '0' by the USART peripheral circuitry. When disabling transmit (TXEN = 0), the TRISB<2> bit should be set to '1' to configure the RB2/TX/CK pin as an input.

In Synchronous mode, when changing from transmit to receive, clear the TXEN bit first, then set TRISB<1> to '1' to configure the RB1/RX/DT pin as an input before setting SREN or CREN to receive.

When disabling the USART (SPEN = 0), TRIS<2:1> should be reconfigured for input or output as required by the application.

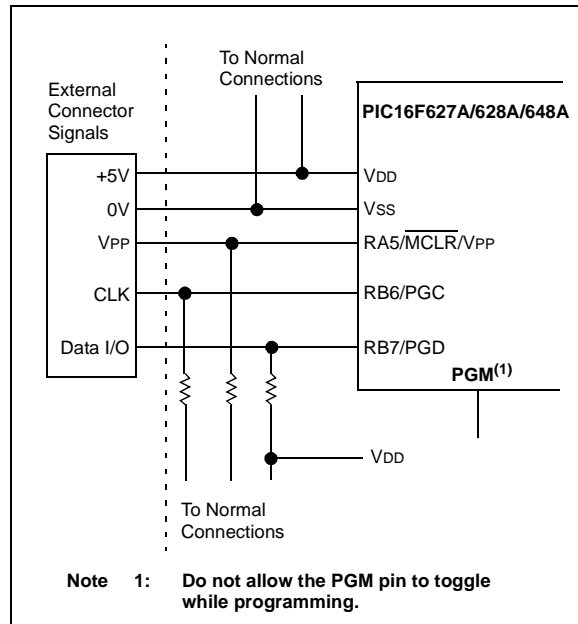
FIGURE 14-18: TYPICAL IN-CIRCUIT SERIAL PROGRAMMING™ CONNECTION

Section 14.11: In-Circuit Serial Programming and Figure 14-18: Typical In-Circuit Serial Programming Connection. The following paragraph and Note box are being added to the end of Section 14.11 and Figure 14-18 is updated to include PGM, noted in bold.

If LVP is not being used for programming, but the LVP Configuration bit is set (or LVP feature is enabled), the PGM pin must not be allowed to toggle while programming. The PGM pin is edge sensitive and if an edge is detected during programming, it may cause the PC to reset. If the LVP feature is disabled, the PGM pin will have no effect on programming.
