PIC32MZ EMBEDDED CONNECTIVITY (EC)

PIC32MZ Embedded Connectivity (EC) Family Silicon Errata and Data Sheet Clarification

The PIC32MZ Embedded Connectivity (EC) family of devices that you have received conform functionally to the current Device Data Sheet (DS60001191D), except for the anomalies described in this document.

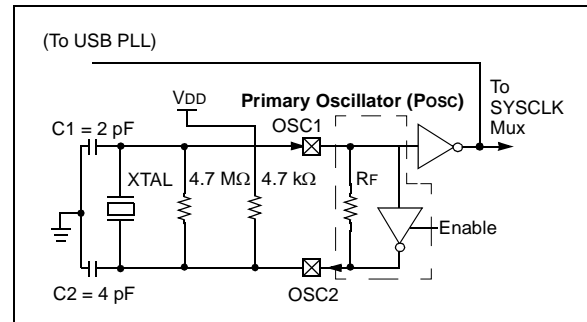
No other crystals are guaranteed to function 100% over voltage, temperature, and population. Adequate testing required in your application to ensure reliable operation.

The following figure shows the required configuration.
