PIC16F627A/628A/648A

PIC16F627A/628A/648A Rev. A Silicon/Data Sheet Errata

The PIC16F627A/628A/648A parts you have received conform functionally to the Device Data Sheet (DS40044F), except for the anomalies described below.

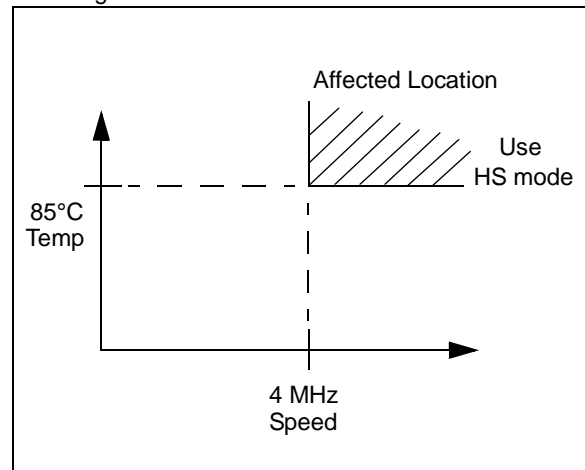
When using the EC OSC mode at frequencies >4 MHz and temperatures >85°C, the part may execute incorrectly from the program memory, causing malfunction.

This problem only affects E-temp parts. Industrial grade parts are unaffected. HS mode should be used for frequencies >4 MHz at extended temps. All other clock modes work to their specified ranges.

Note: This problem is corrected in PIC16F648A Rev. A3. (Date code 0420XXX and later.)
